Preliminary Report

**Accident involving Air India's B787-8 aircraft bearing registration VT-ANB
at Ahmedabad on 12 June 2025**

**Government of India
Ministry of Civil Aviation
Aircraft Accident Investigation Bureau**

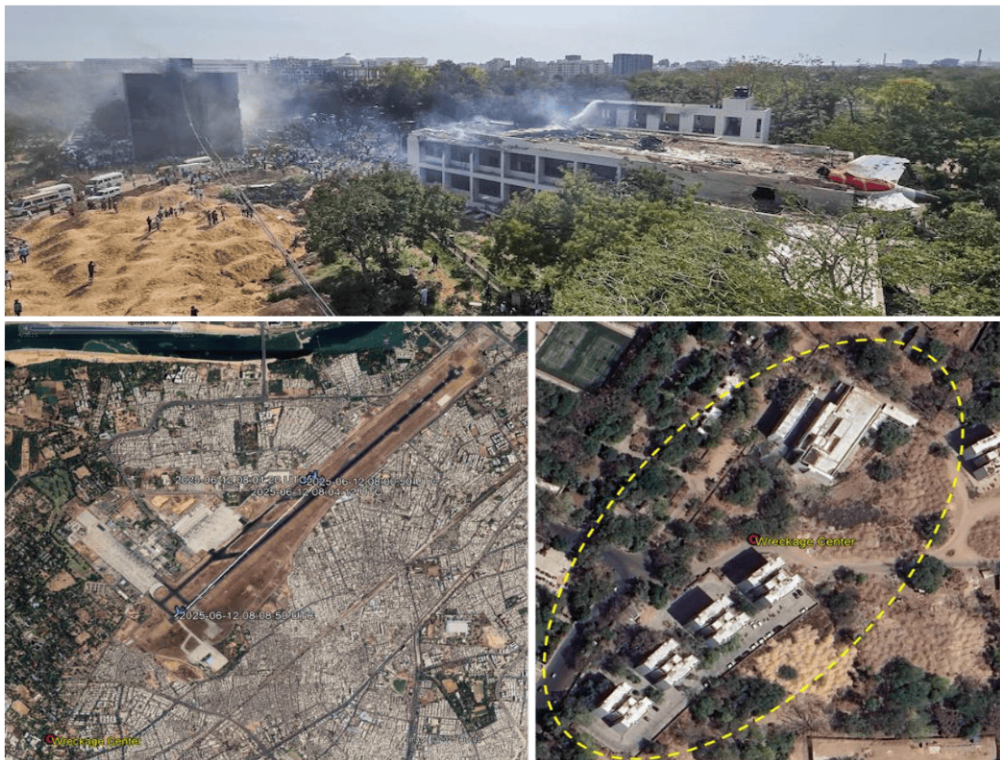
Figure 1 Accident Site with respect to airport (left) and debris field

The Aircraft was destroyed due to impact with the buildings on the ground and subsequent fire. A total of five buildings shown in the figure below were impacted and suffered major structural and fire damages.

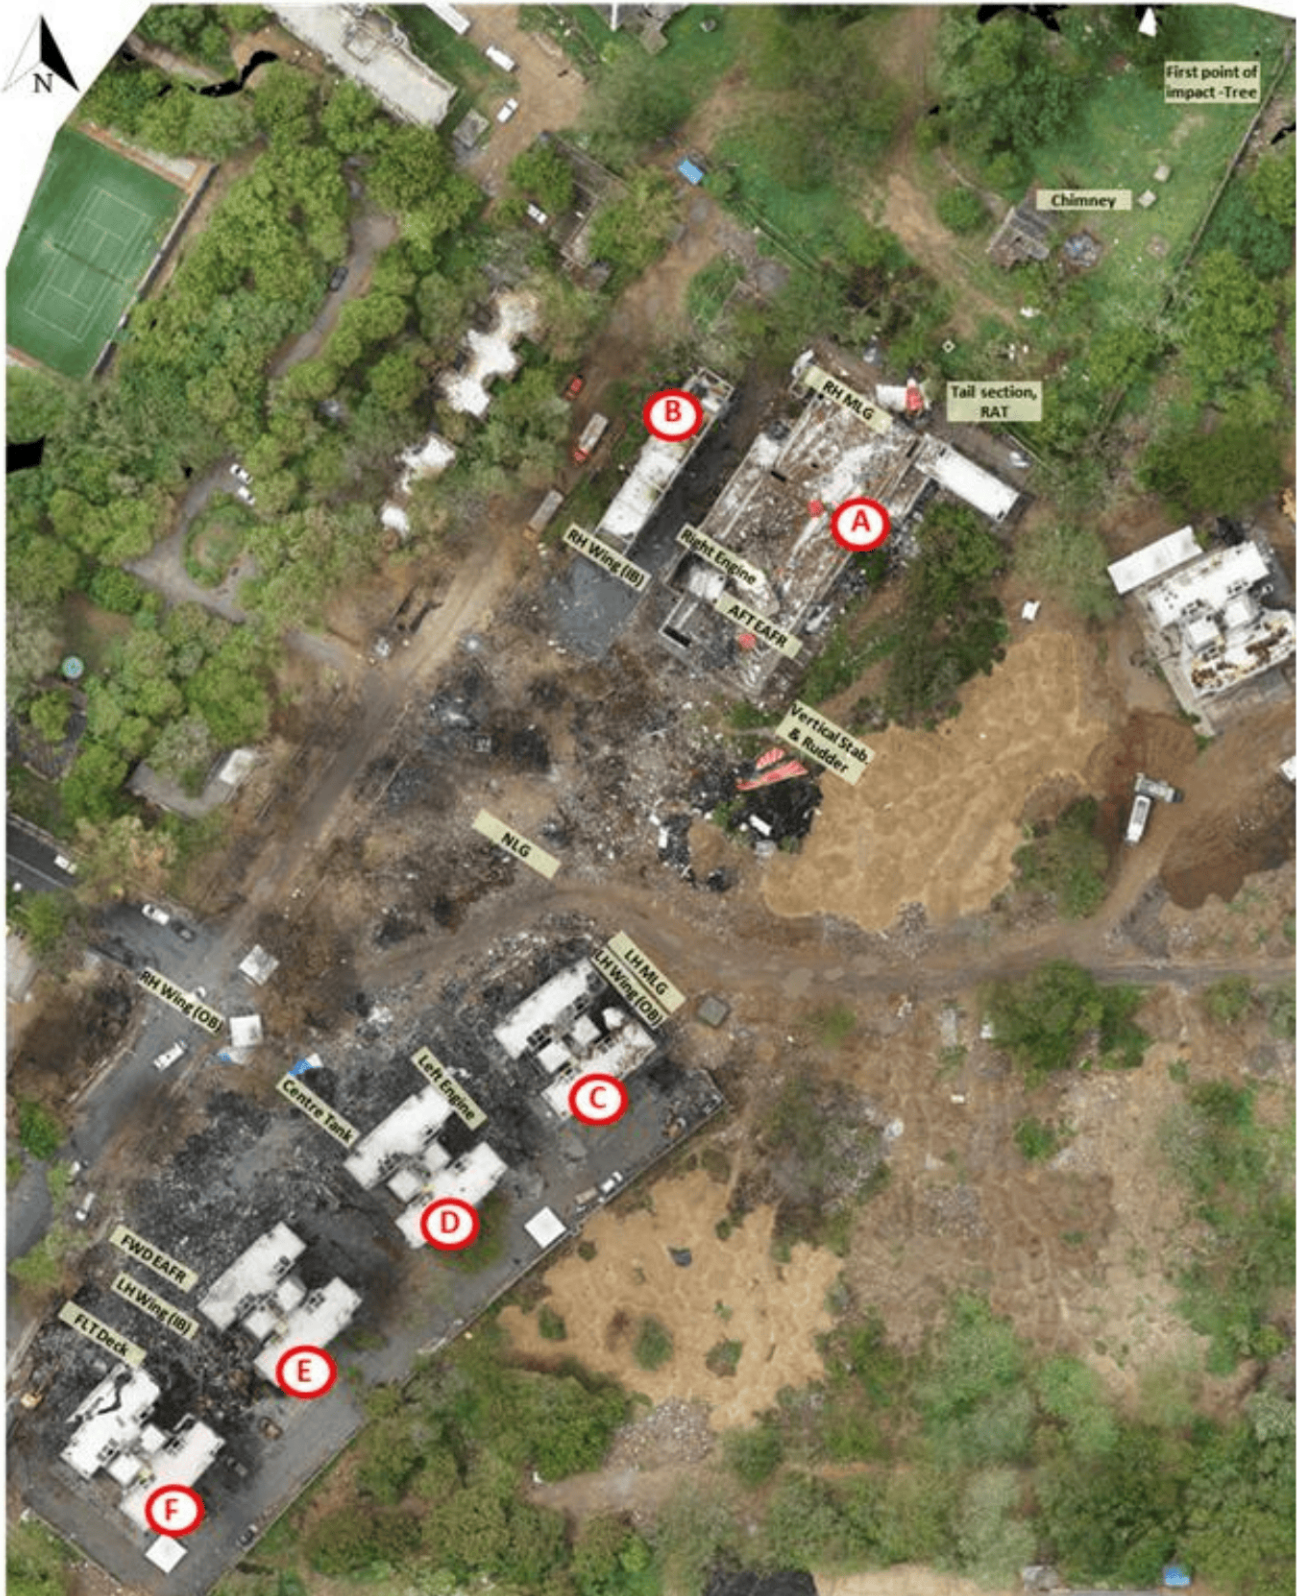
Figure 2 Wreckage layout

After takeoff, the aircraft impacted the BJ Medical College hostel which is 0.9 NM from the departure end of Runway 23. The Emergency Locator Transmitter (ELT) was not activated during this event. The wreckage, from the first impact point till the last identified aircraft item, was distributed in an area of approx. 1000 ft * 400 ft. A layout of the crash site has been given in Fig. 2 indicating the significant parts of the aircraft. The buildings at the wreckage site have been labelled alphabetically from A-F in the layout for easy reference.

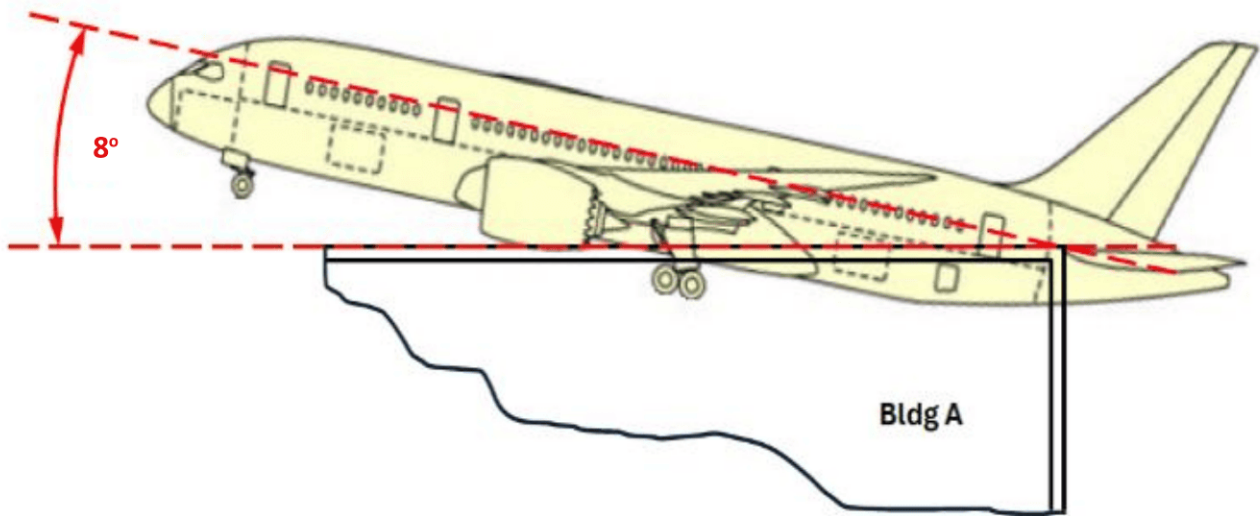
Figure 3 Aircraft attitude at the time of impact with Building A

As the aircraft was losing altitude, it initially made contact with a series of trees and an incineration chimney inside the Army Medical Corps compound before impacting the northeast wall of the Building A. The distance between the tree on which the aircraft made its initial contact and the point on the Building A where the aircraft impacted is 293 ft. As the

aircraft moved forward, it continued fragmenting and collided with other structures and vegetation. The impact witness marks on the building and airplane indicated a likely nose-up attitude (about 8°) and wings level.

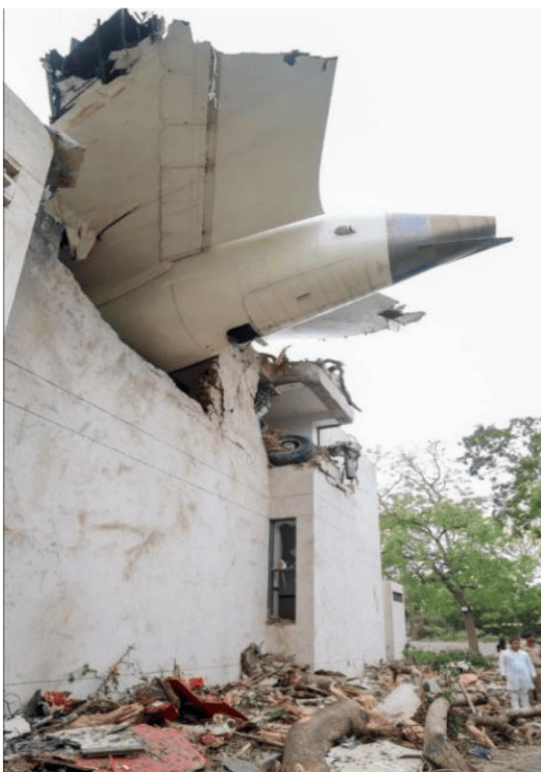
Figure 4 Tail section & RH MLG embedded in the building A

The vertical stabilizer (*fig. 5*) separated from the aft fuselage and came to rest about 200 feet south of the initial point of contact with the Building A. The tail section and the RH Main Landing Gear (MLG) of the aircraft were found embedded in the northeast wall of the Building A while the rest of the airplane continued its forward movement.

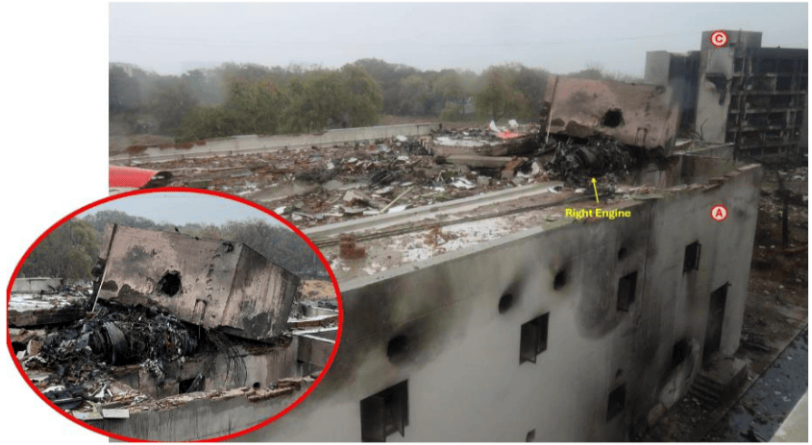
Figure 6 RH Engine

As the airplane continued its path across the roof of the Building A the right engine (*fig. 6*) struck the concrete water tank structure, separated from the airplane and rested underneath the water tank structure facing a heading of approx. 226 degrees near south-west wall of the Building A.

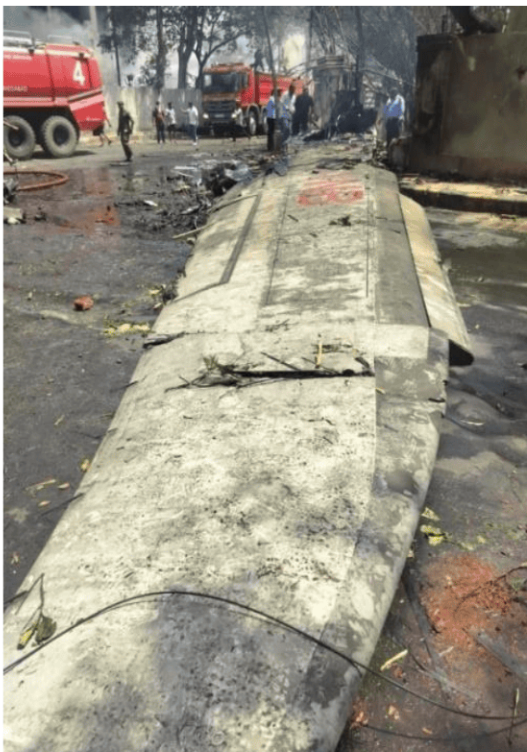
Figure 7 : RH Wing Outboard

The right-wing mid-section and the outboard section (*fig.7*) was about 280 feet and 520 feet southwest respectively from the initial point of contact with the Building A.

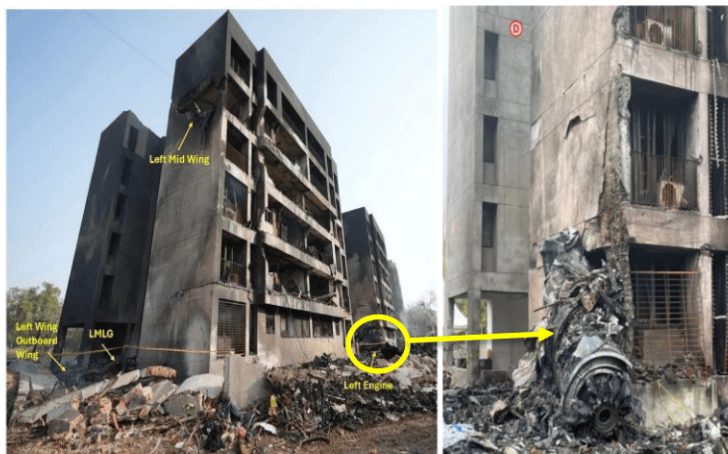
Figure 8 LH Engine

The left engine (*fig.8*) got separated from the airplane and struck the north corner of Building D at the ground level where it remained and was roughly perpendicular to the right engine resting position, at heading of approx. 326 degrees. The wall was pushed into the

building and the northwest building column was damaged such that portions of the concrete

were missing and exposing the internal metal rebar. The engine, remaining portions of attached cowling, and the surrounding area were heavily damaged by fire.

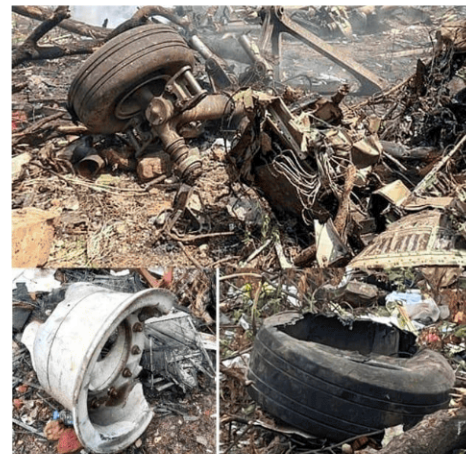
Figure 9 Nose Landing Gear

The nose landing gear (NLG) (*fig. 9*) was found on the ground about 307 feet southwest from the initial point of contact with Building A.

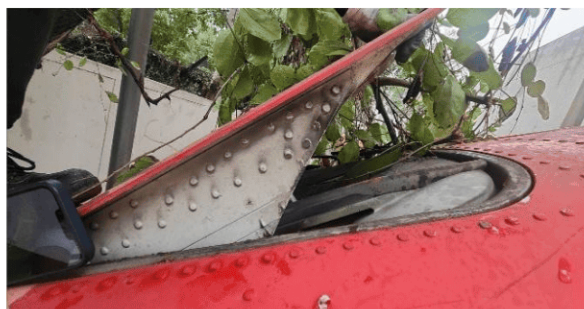
Figure 10 APU Air Inlet Door

After the tail section was brought down, the APU was inspected and found intact inside the APU compartment. The APU air inlet door (*fig. 10*), which was intact, was found open. The fuselage fragmented and sustained thermal damage as it traveled along the northwest faces of Buildings C, D, E, and F with the furthest debris observed at about 765 feet southwest from the initial point of contact with building A. The flight deck area and windshield support structure came to rest at about 650 feet southwest from the initial point of contact with Building A.

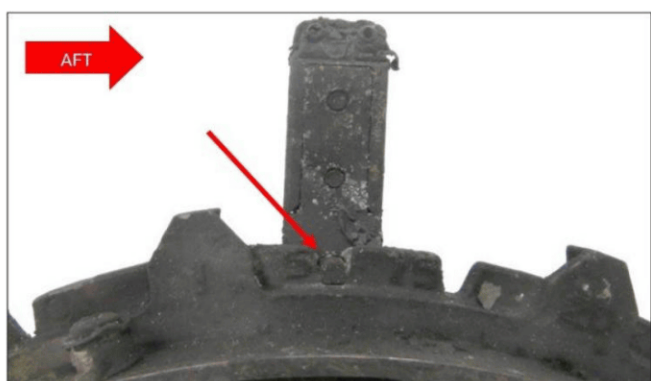
Figure 11 Flap Handle Lever

The flap handle assembly (*fig.11*) sustained significant thermal damage. The handle was found to be firmly seated in the 5-degree flap position, consistent with a normal takeoff flap setting. The position was also confirmed from the EAFR data. The landing gear lever was in “DOWN” position. (*fig.12*)

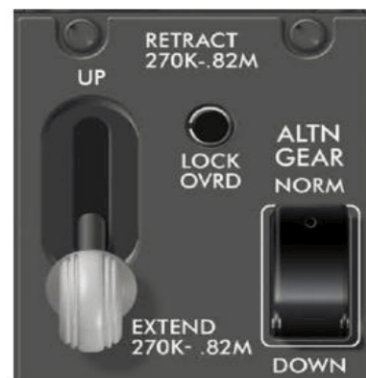
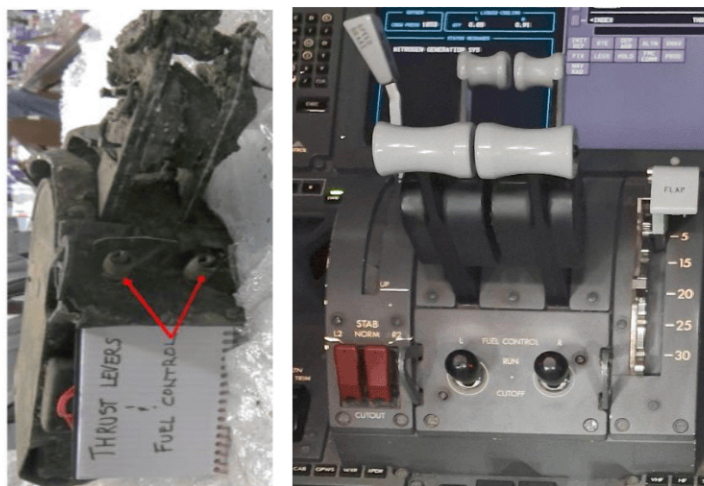
Figure 13 Thrust Lever Quadrant & Fuel Control Switch

The thrust lever quadrant sustained significant thermal damage. Both thrust levers were found near the aft (idle) position. However, the EAFR data revealed that the thrust levers remained forward (takeoff thrust) until the impact. Both fuel control switch were found in the “RUN” position. (*fig.13*) The reverser levers were bent but were in the “stowed” position. The wiring from the TO/GA switches and autothrottle disconnect switches were visible, but heavily damaged.

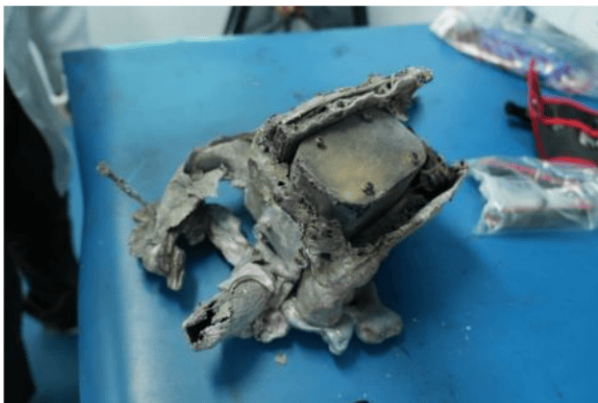
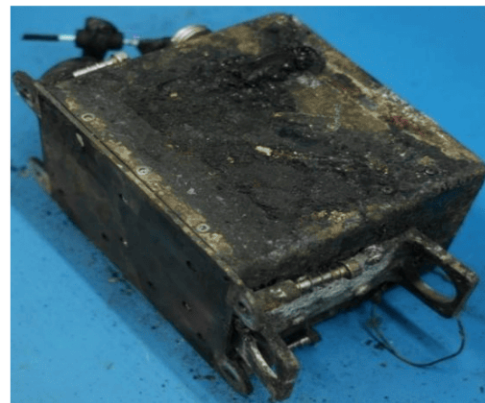
Figure 14 EAFR AFT & FWD

The aft EAFR was located on the roof top of Building A on 13th June 2025. The EAFR had impact and thermal damages to the housing. The wires were protruding from the housing and the connectors were burnt.

The forward EAFR was located on 16th June 2025 from the wreckage debris besides the Building F. The EAFR was burnt and covered in soot. The EAFR was still attached to the

equipment shelf with part of the connector melted but still connected. The ULB was still connected to the housing and the lithium battery was also attached to the equipment shelf, which was removed later prior to transportation.

The aft EAFR was substantially damaged and could not be downloaded through conventional means. The CPM was opened to inspect the memory card. The damage was extensive.

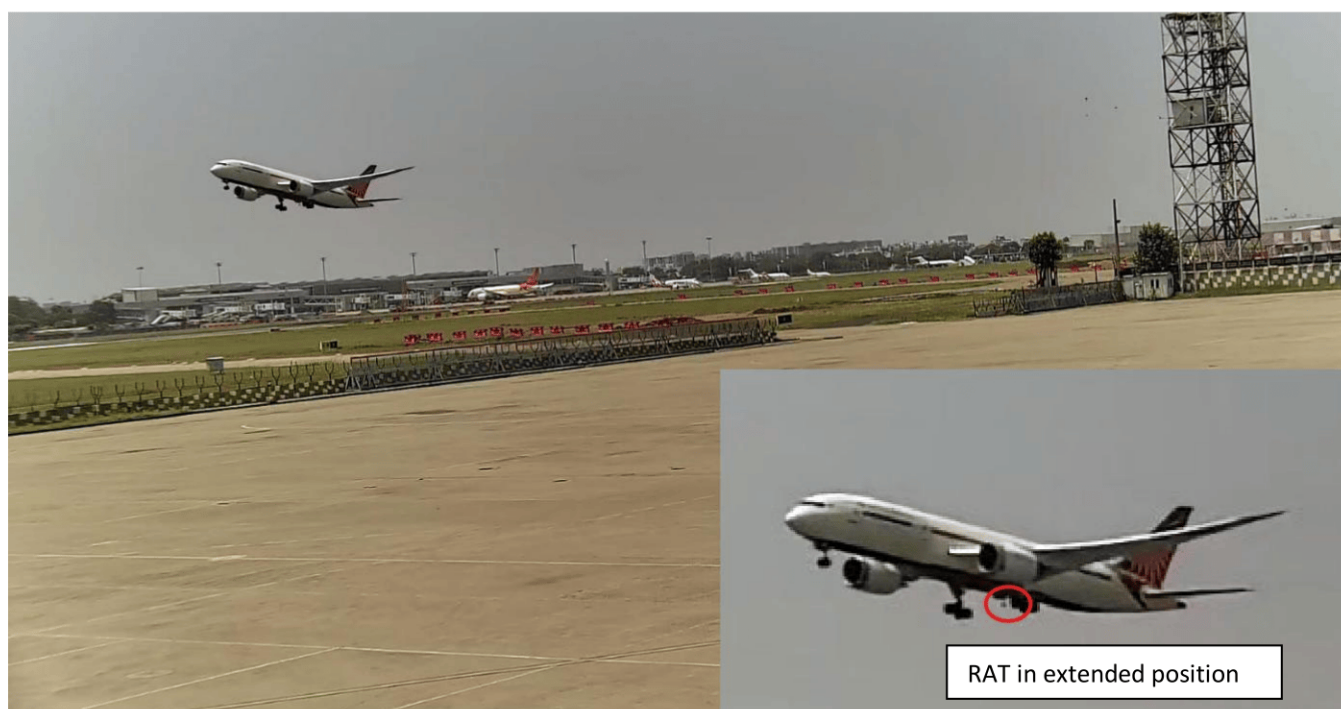
The CCTV footage obtained from the airport showed Ram Air Turbine (RAT) getting deployed during the initial climb immediately after lift-off (*fig. 15*). No significant bird activity is observed in the vicinity of the flight path. The aircraft started to lose altitude before crossing the airport perimeter wall.

Figure 15 CCTV screenshot of RAT Deployment
